INSPECTING ON THE EDGE — UNDERSTANDING PUNCH TIP WEAR

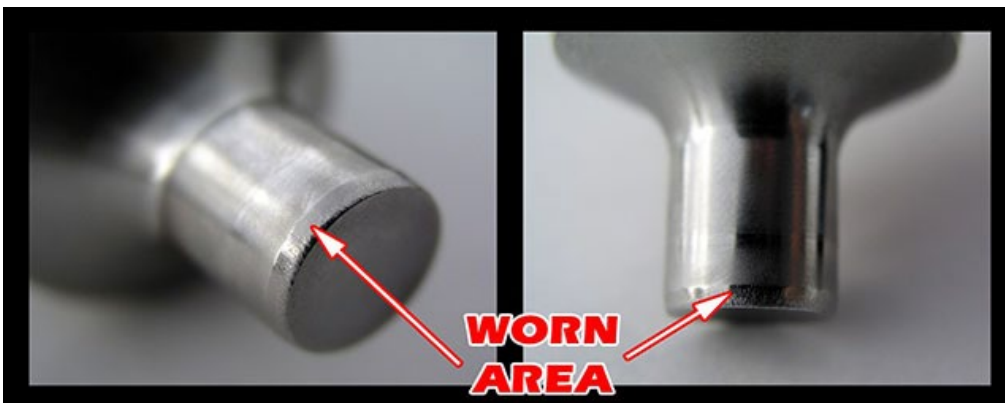
Illustration A: Severe outer tip edge wear.

Punch tip edge wear can result from a number of conditions and may cause a myriad of problems including raised edges on the final compressed tablet, commonly referred

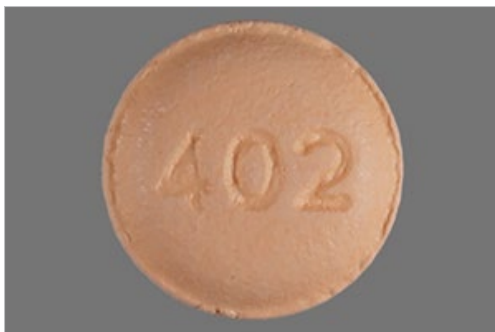
Illustration B: Excessive flashing on tablet

to as “flashing” (Illustration B). Tablet flashing, in turn, can cause many other issues after the compression event. When tablets are subjected to de-dusting, the flashed edges may break off and cause rough, poorly defined edges. Tablets with flashing and rough edges can be difficult to film coat and can lead to loose particles adhering to the coated tablet surface. To minimize defects and downtime it is important to understand the most frequent causes of punch tip edge wear.

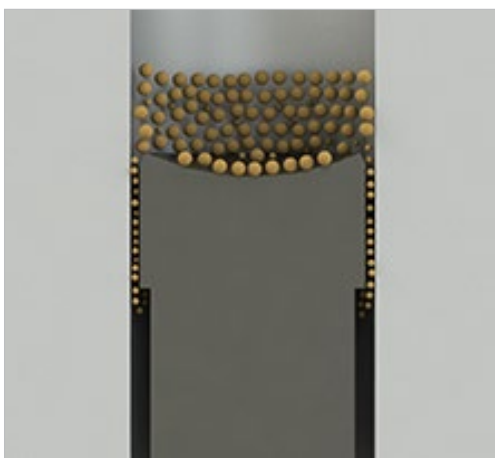
Illustration C: Tip wear on O.D. edge and small particle sifting inside die bore.

Particle size can also affect tip wear. When small particles known as fines are present, they can sift into the gap between the punch tip and die bore (Illustration C). These small particles, combined with the cyclic motion of the punches can cause wear on the outer edges of punch tips. While often there is little or no choice as to the components of a formulation, controlling particle size and tip-to-die bore clearance can work together to reduce unnecessary tip wear and extend tool life.

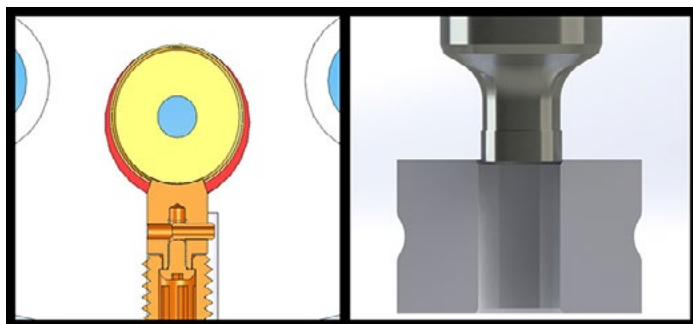
Illustration D: “Drop in” die pushed out of center by die lock screw causing tip edge contact with the lead-in chamfer of the die.

Dies that just “drop in” are easier to install, but consider what happens when the die lock is tightened. The die, and more importantly the die bore, will be pushed out of center to the punch tips. It is vital that the die bore be accurately centered to the punch tips. If not centered, the upper punch tip edge may strike the lead-in chamfer at the top of the die upon entry (Illustration D). Repetitive striking will quickly cause wear to the edge of the upper tip (Illustration E). With continued use this edge wear can cause flashing on the tablets as previously described. The striking can be so severe that it may curl metal of the tip inwards into the cup. This condition is called J-hook (Illustration F), and may cause capping and lamination of the tablets. Also if the die bore is not well centered, the lower punch tip will have contact with the bore on one side with all the clearance on the opposite side. This increased clearance will allow product to

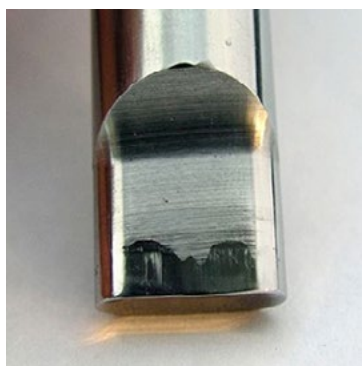
Illustration E: Resulting damage to punch tips

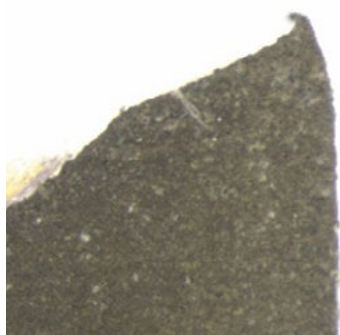
Illustration F: Typical J-hook

Steps to strengthen the edge of the punch cup include reducing the slope of the cup and more importantly, introducing appropriate amount of land into the tablet design. Land unfortunately gets a bad reputation, as many believe additional land will cause soft edges and more difficulty with film coating. Most tool vendors know the value of land and may incorporate it into the design. However, many are forced to use “minimal” land width which is usually only approximately 5% of cup depth. Knowledgeable tablet designers consider that land width should be closer to 10% of cup depth, and occasion-

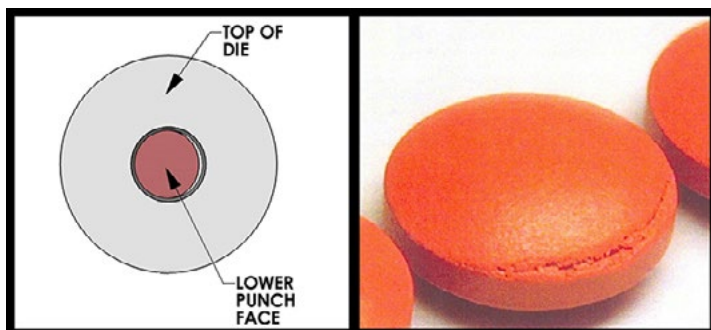
Illustration G: Off center lower face and resulting tablet defect

sift into the gap, also potentially cause excessive wear previously described. It may also create a defect to the tablet on the lower edge where the tablet band and the cup face meet (Illustration G).

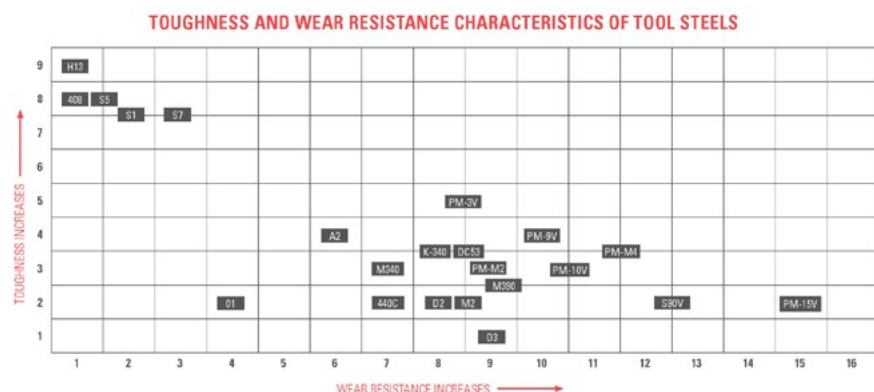
Illustration H: Toughness vs. Wear Resistance of various tool steels.

types for challenging formulations. Abrasive wear resistant tool steel grades include AISI (DIN) D2 (1.2379), M2 (1.3343), DC-53 and K-340. For very abrasive products, punches can be produced from premium wear resistant PM grade steels (PM=Particle Metallurgy), such as, PM-3V, PM-9V and PM-10V. As the hardness increases on premium tool steels so does the abrasive wear resistance, but it must be noted that the impact toughness decreases somewhat (Illustration H). Some steels are required to be cryogenic tempered (-184°C, -300°F)

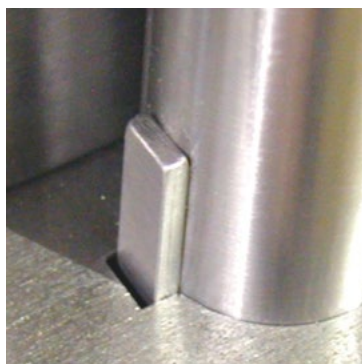
Illustration I - Part One:
Punch key not pre-loaded

PRESS SET-UP - Press set-up can be critical in reducing and preventing accelerated tip wear. Pre-loading is the process of twisting the keyed upper punch in the direction of turret rotation while using the upper punch to set the angular alignment of the die bore shape. Pre-loading simulates the rotational forces that the upper punch experiences when the press is in operation. When using shaped/keyed tooling, pre-loading is often not practiced. All presses have clearance in the key slot of the turret, which may increase further as the turret wears. If the punches are not pre-loaded when setting the die alignment, the upper punch will shift angularly as the turret rotates (Illustration I). This creates angular misalignment between punch tip and die bore resulting in accelerated wear to the outer edge of the upper punch tip due to contact with the die bore as it enters. Following simple set-up procedures such as pre-loading, combined with periodic turret inspections, can greatly reduce unnecessary tip wear.

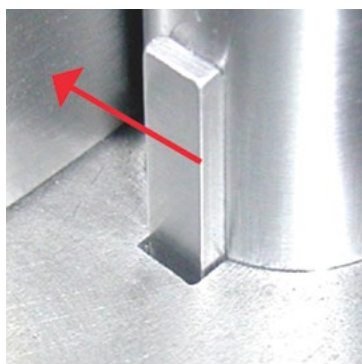
Illustration I - Part Two:
Punch key flush with left side of slot after pre-load applied (Note; these photos depict CW rotating turret)

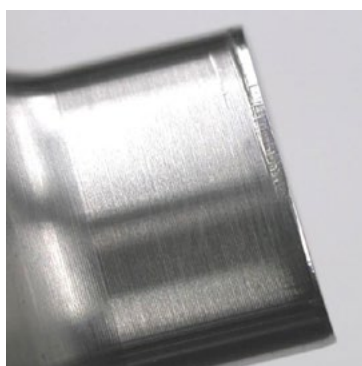
Illustration I - Part Three: Tip damage from lack of pre-load

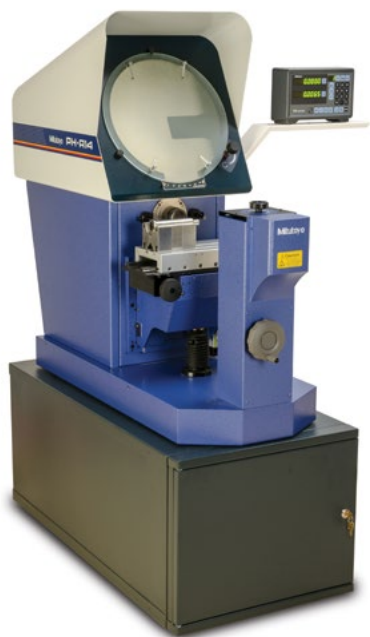
Illustration J - Part One:
Horizontal Optical Comparator

Visual inspection for tip edge wear is quite challenging, especially without magnification. The quickest and most efficient method is to use a [horizontal optical comparator](#) (Illustration J). An optical comparator (often called a comparator) is an apparatus that applies the principles of optics to the inspection of manufactured parts. In a comparator, the magnified silhouette of a punch tip is projected upon a screen, usually at 10x, but can also be at 20x or even greater magnification. The wear of the part can be easily inspected, and even measured against prescribed limits. Unfortunately, a comparator is not used often in the industry but is a valuable piece of equipment. For a reasonable investment, it is the only efficient method to check punch tip wear.

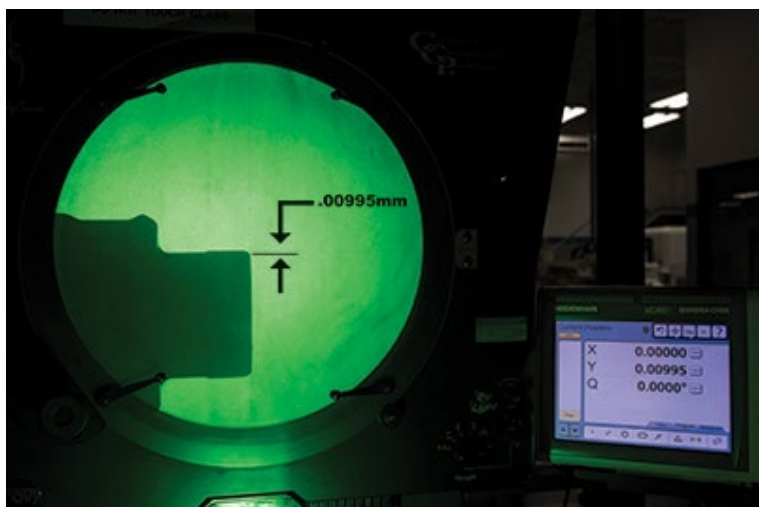
Illustration J - Part Two: Inspection of punch tip with worn edge on Optical Comparator
